## **August 14, 2003 Outage Sequence of Events U.S./Canada Power Outage Task Force September 12, 2003**

### August 14, 2003 Outage Sequence of Events

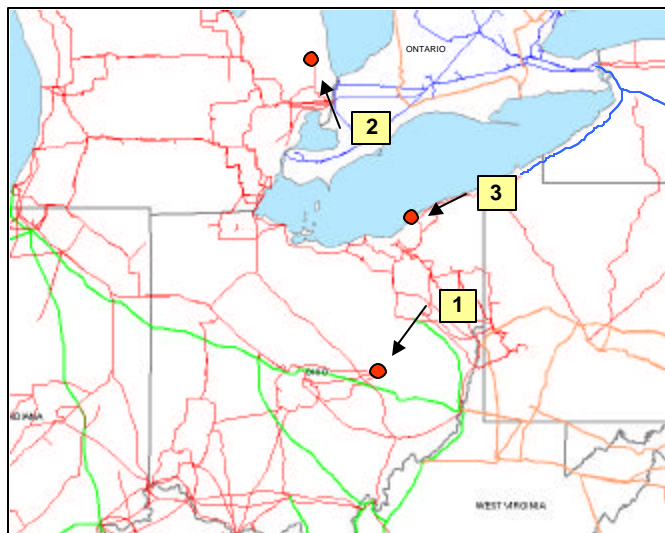
12:05:44 – 1:31:34 PM – Generator trips

1. 12:05:44 – Conesville Unit 5 (rating 375 MW)
2. 1:14:04 – Greenwood Unit 1 (rating 785 MW)
3. 1:31:34 – Eastlake Unit 5 (rating: 597 MW)

Conesville plant is in central Ohio and Greenwood plant is north of the Detroit area. Greenwood Unit 1 tripped at 1:14:04 and returned to service at 1:57. Eastlake Unit 5 is in northern Ohio along the southern shore of Lake Erie and is connected to the 345 kV transmission system. These generating unit trips (shutdowns) caused the electric power flow pattern to change over the transmission system.

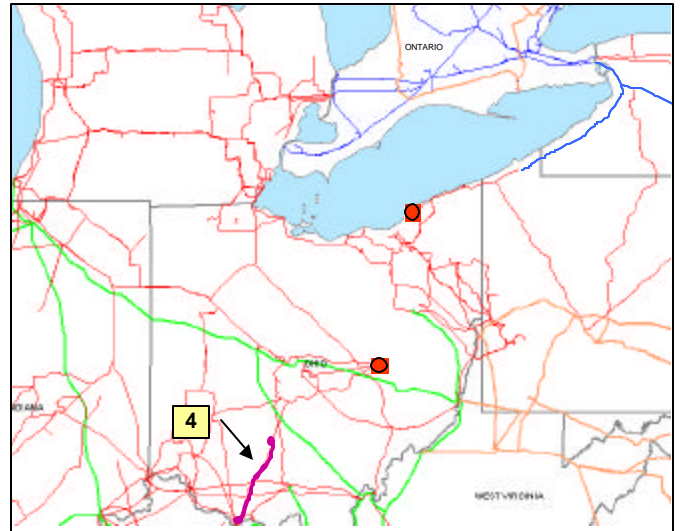
#### 4. Stuart – Atlanta 345 kV

### 2:02 PM – Transmission line disconnects in southwestern Ohio

This line is part of the transmission pathway from southwestern Ohio into northern Ohio. It disconnected from the system due to a brush fire under a portion of the line. Hot gases from a fire can ionize the air above a transmission line, causing the air to conduct electricity and short-circuit the conductors.

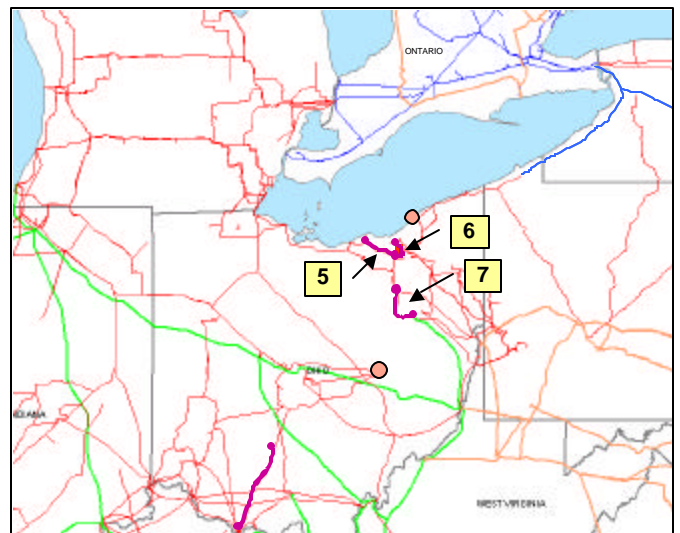
### 3:05:41 – 3:41:33 PM – Transmission lines disconnect between eastern Ohio and northern Ohio

#### 5. 3:05:41 – Harding-Chamberlain 345 kV

#### 6. 3:32:03 – Hanna-Juniper 345 kV

#### 7. 3:41:33 – Star-South Canton 345 kV

These three transmission lines are part of the pathway into northern Ohio from eastern Ohio. At this time, the reason for the Harding-Chamberlain line going out of service is unknown. The Hanna-Juniper line contacted a tree, creating a short-circuit to ground that caused the line to disconnect itself. The Star-South Canton line had disconnected and reclosed twice earlier in the day, but the significance of those events is not yet clear.

With these lines disconnected, the effectiveness of the transmission path from eastern Ohio into the northern Ohio area was reduced. The electricity that had been flowing over these lines instantly began flowing over other transmission lines, including the underlying 138 kV systems, that connect northern Ohio to the grid. However, this new power flow pattern began to overload those other lines as well. As voltage was dropping, demand of about 600 MW disconnected in the northern Ohio area from industrial customers (whose motors dropped off line due to low voltage) and distribution-level customers who were disconnected automatically from the 138 and 69 kV transmission system.

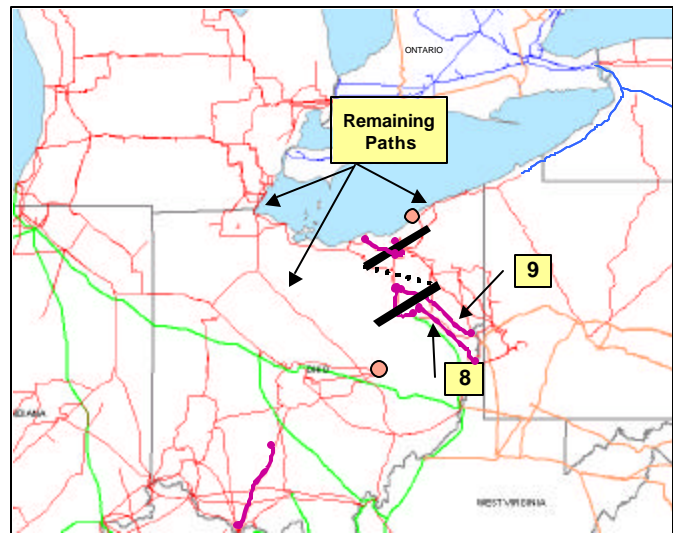
3:45:33 – 4:08:58 PM – Remaining transmission lines disconnect from eastern into northern Ohio

8. 3:45:33 – Canton Central-Tidd 345 kV

9. 4:06:03 – Sammis-Star 345 kV

Canton Central-Tidd disconnected at 3:45:33 and reconnected 58 seconds later. However, the Canton Central 345/138 kV transformers disconnected and did not reconnect, isolating the 138 kV system from the 345 kV support at the Canton Central substation. The Sammis-Star 345 kV line then disconnected at 4:06:03, which completely blocked the 345 kV path into northern Ohio from eastern Ohio. This left only three paths for power to flow into northern Ohio: 1) from northeastern Ohio and Pennsylvania around the southern shore of Lake Erie, 2) from southern Ohio (recall, however, that part of that pathway was severed following the Stuart-Atlanta line trip at 2:02), and 3) from eastern Michigan. This also substantially weakened northeast Ohio as a source of power to eastern Michigan, making the Detroit area more reliant on the west-east Michigan lines and the same southern and western Ohio transmission lines.

During the period 3:42:49-4:08:58, multiple 138 kV lines across northern Ohio disconnected themselves. This blacked out Akron and the areas west and south.

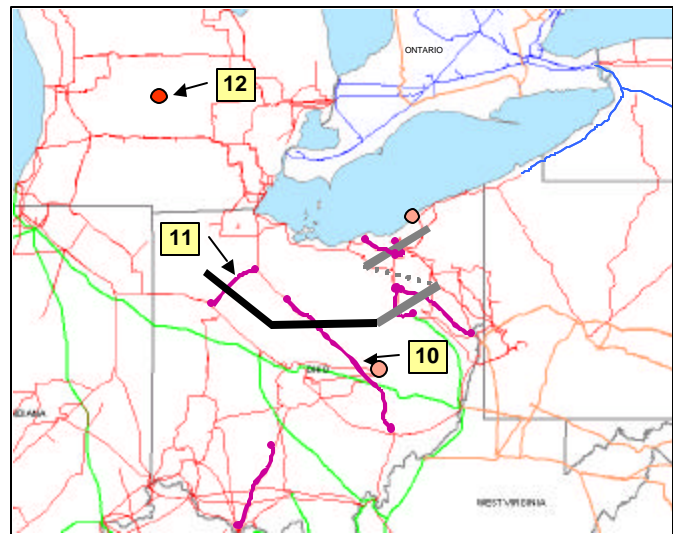
4:08:58 – 4:10:27 PM – Transmission lines into northwestern Ohio disconnect, and generation trips in central Michigan

10. 4:08:58 – Galion-Ohio Central-Muskingum 345 kV

11. 4:09:06 – East Lima-Fostoria Central 345 kV

12. 4:09:23-4:10:27 – Kinder Morgan (rating: 500 MW; loaded to 200 MW)

When the Galion-Ohio Central-Muskingum and East Lima-Fostoria Central transmission lines disconnected, this blocked the transmission paths from southern and western Ohio into northern Ohio and eastern Michigan. Thus the combined northern Ohio and eastern Michigan load centers were connected only by the transmission lines from: 1) northeastern Ohio and Pennsylvania along the southern shore of Lake Erie; 2) western Michigan via the west-east lines that cross the state; and 3) Ontario. Eastern Michigan was connected to northern Ohio only by three 345 kV transmission lines near the southwestern bend of Lake Erie.

The Kinder Morgan generating unit tripped (shut down) in central Michigan (loaded to 200 MW).

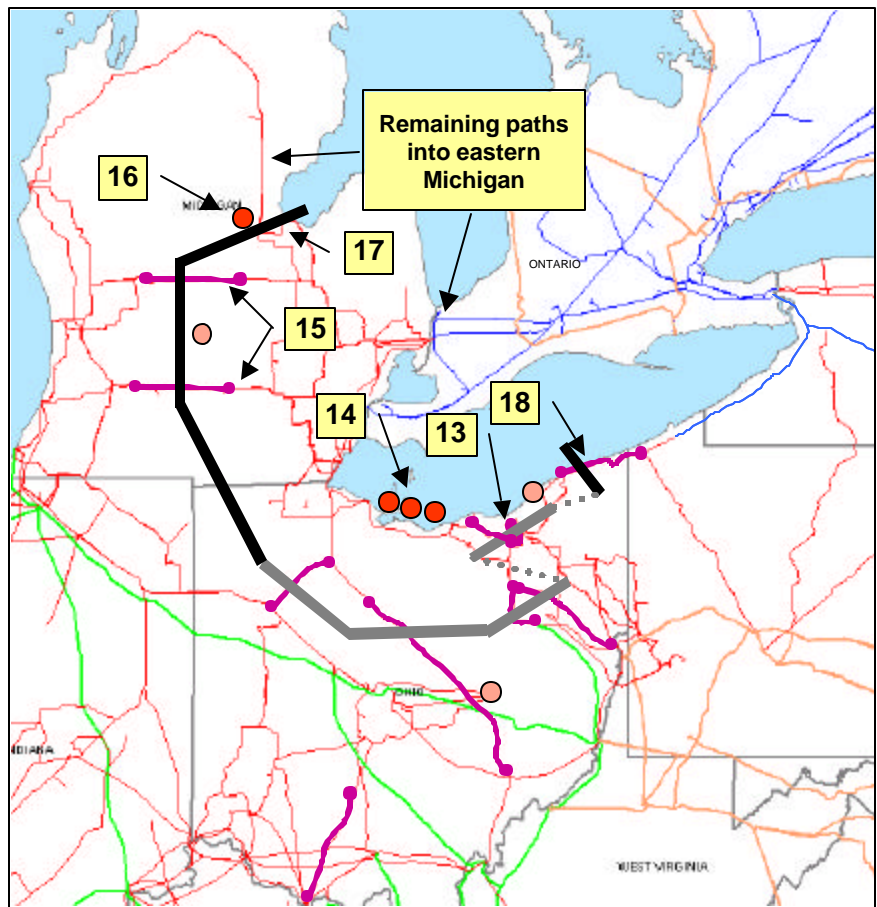
4:10:00 – 4:10:38 PM – Transmission lines disconnect across Michigan and northern Ohio, generation trips off line in northern Michigan and northern Ohio, and northern Ohio separates from Pennsylvania

- 13. 4:10 – Harding-Fox 345 kV
- 14. 4:10:04 – 4:10:45 – Twenty generators along Lake Erie in northern Ohio (loaded to 2174 MW total)
- 15. 4:10:37 – West-East Michigan 345 kV
- 16. 4:10:38 – Midland Cogeneration Venture (loaded to 1265 MW)
- 17. 4:10:38 – Transmission system separates northwest of Detroit
- 18. 4:10:38 – Perry-Ashtabula-Erie West 345 kV

Twenty generators (loaded to 2174 MW) tripped off line along Lake Erie during the period 4:10:04 – 4:10:45. The loss of this generation increased the power flows into the northern Ohio and eastern Michigan load centers on the remaining paths, which included the west-east transmission lines that cross Michigan.

The west-east Michigan 345 kV paths then disconnected at 4:10:37, leaving eastern Michigan connected by only a circuitous path around northern Michigan that disconnected one second later, and the connections to Ontario and northern Ohio. Investigators are still studying the power flows that resulted.

At 4:10:38, the Midland Cogeneration Venture (MCV), loaded to 1265 MW, tripped off line.

The MCV generation trip imposed heavier flows on the remaining transmission system, and left eastern Michigan and northern Ohio with very depressed voltages. The remaining transmission paths into the Detroit area from the northwest separated.

At 4:10:38, the Perry-Ashtabula-Erie West 345 kV transmission line tripped, severing the path into the northern Ohio area from Pennsylvania along the southern shore of Lake Erie.

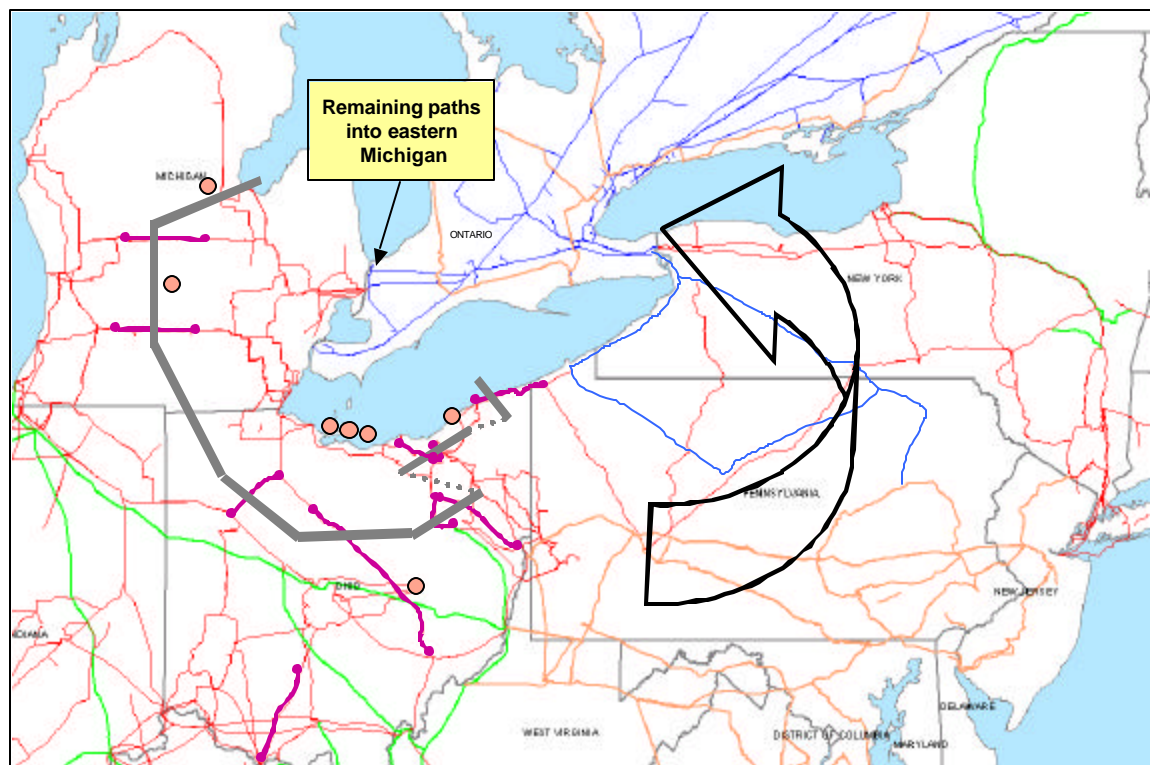
When the Perry-Ashtabula-Erie West 345 kV transmission line disconnected at 4:10:38, the entire eastern Michigan and northern Ohio load centers had little generation left available to them and the voltage was declining. The only connection between those load centers and the rest of the Eastern Interconnection was at the interface between the Michigan and Ontario systems. Also, the frequency was declining in northern Ohio in those areas that had separated from the Interconnection.

When the transmission lines along the southern shore of Lake Erie disconnected, the power that had been flowing along that path immediately reversed direction and began flowing in a giant loop counterclockwise from Pennsylvania to New York to Ontario and into Michigan.

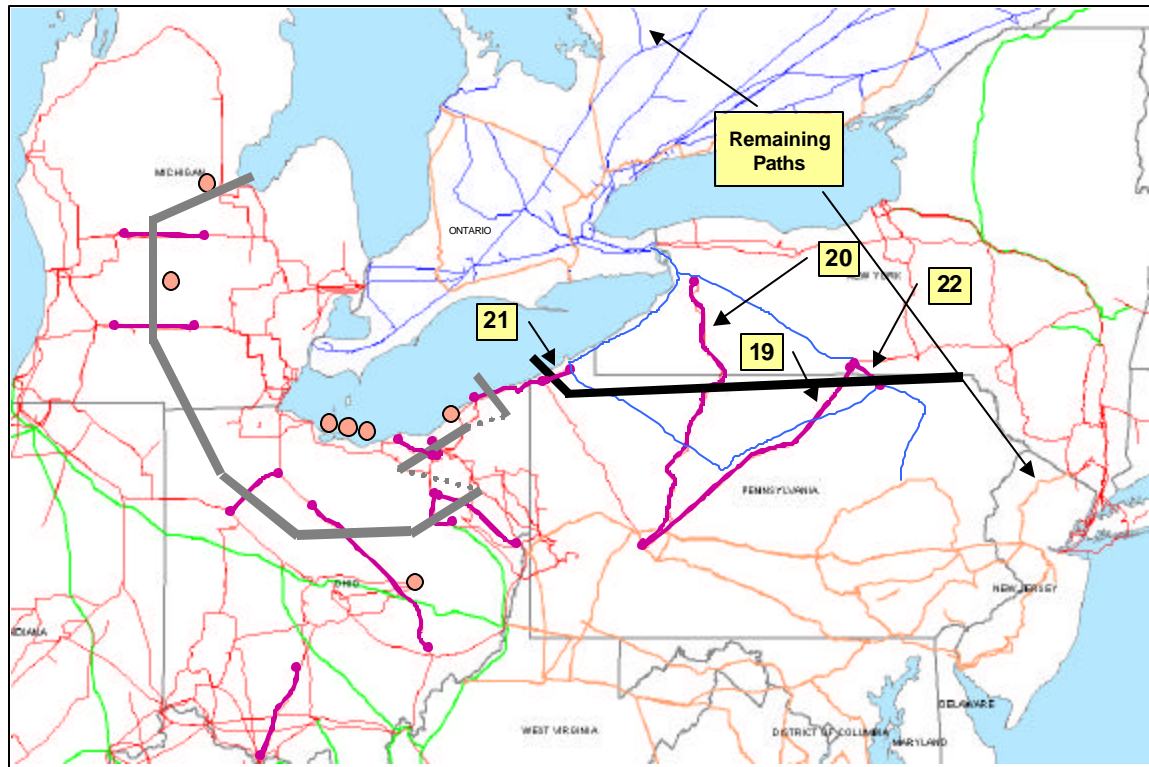
4:10:40 – 4:10:44 PM – Four transmission lines disconnect between Pennsylvania and New York

19. 4:10:40 – Homer City-Watercure Road 345 kV

20. 4:10:40 – Homer City-Stolle Road 345 kV

21. 4:10:41 – South Ripley-Dunkirk 230 kV

22. 4:10:44 – East Towanda-Hillside 230 kV

Responding to the surge of energy flowing north out of Pennsylvania through New York and Ontario into Michigan, these four lines disconnected within four seconds of one another and separated Pennsylvania from New York.

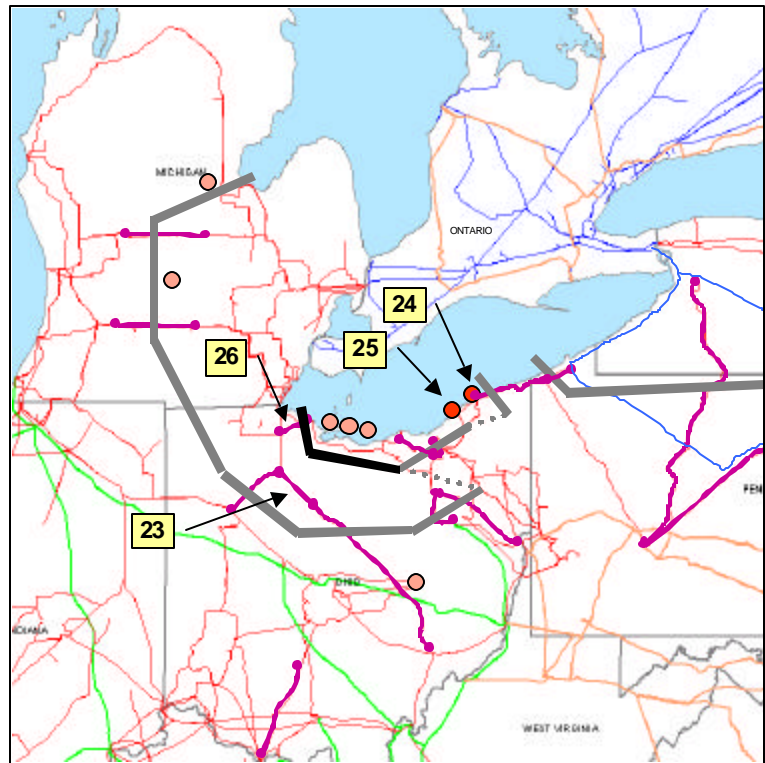
4:10:41 PM – Transmission line disconnects and generation trips in northern Ohio

- 23. Fostoria Central-Galion 345 kV
- 24. Perry 1 nuclear unit (rated 1252 MW)
- 25. Avon Lake 9 unit (rated 616 MW)
- 26. Beaver-Davis Besse 345 kV

The Fostoria Central-Galion line forms part of the pathway from central to northern Ohio. That path was already blocked by the combination of the Galion-Muskingum-Ohio Central line disconnecting at 4:08:58, and the East Lima-Fostoria Central line disconnecting at 4:09:06.

Perry 1 nuclear unit, located on the southern shore of Lake Erie near the border with Pennsylvania, and Avon Lake 9, located near Cleveland, tripped off line at virtually the same time.

When the Beaver-Davis Besse 345 kV line, which connects the Cleveland and Toledo areas, disconnected, it left the Cleveland area isolated from the Eastern

Interconnection. Cleveland area load was disconnected first by automatic underfrequency load shedding, and finally by the disconnection of the transmission lines.

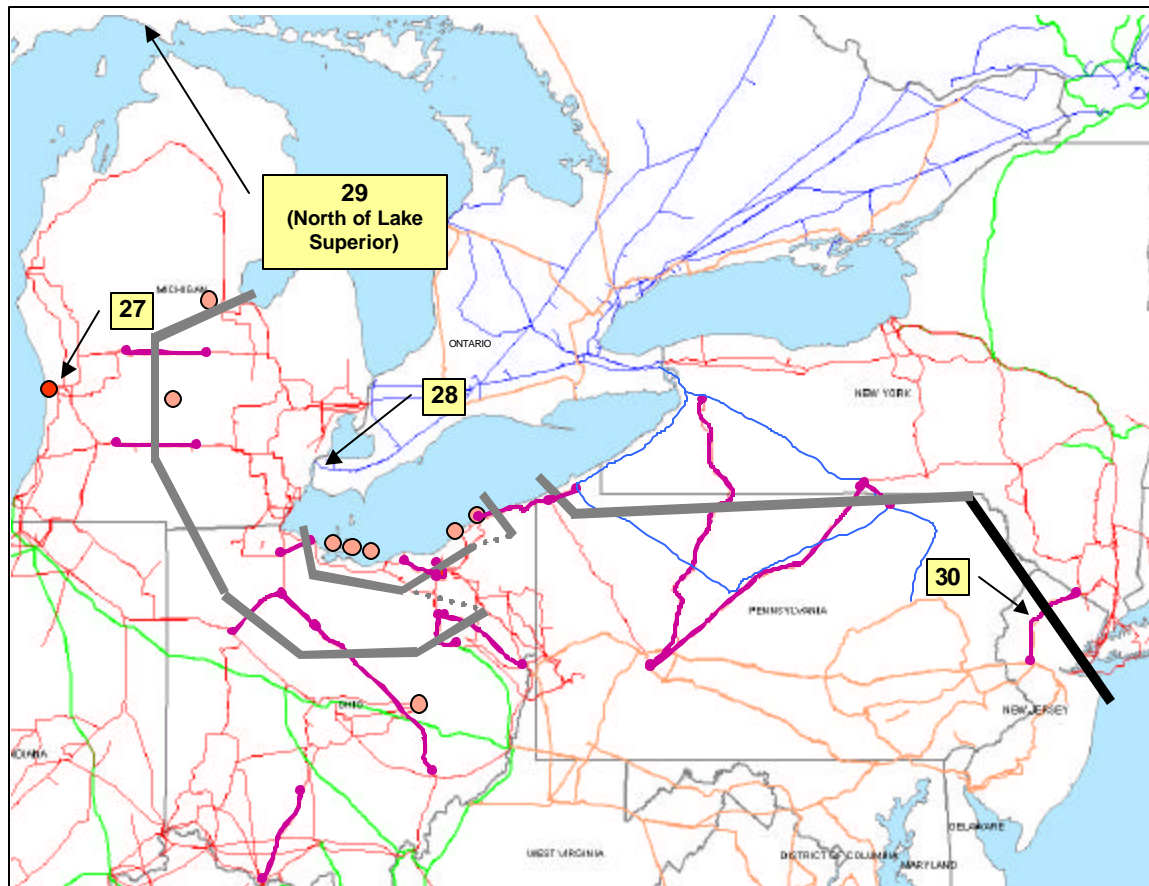
4:10:42 – 4:10:45 PM – Transmission paths disconnect in northern Ontario and New Jersey, isolating the northeast portion of the Eastern Interconnection

27. 4:10:42 – Campbell unit 3 (rated 820 MW) trips

28. 4:10:43 – Keith-Waterman 230 kV

29. 4:10:45 – Wawa-Marathon 230 kV

30. 4:10:45 – Branchburg-Ramapo 500 kV

At 4:10:43, eastern Michigan was still connected to Ontario, but the Keith-Waterman 230 kV line that forms part of that interface disconnected.

At 4:10:45, the Ontario system separated when the Wawa-Marathon 230 kV line disconnected along the northern shore of Lake Superior. The portion of Ontario to the west of Wawa remained connected to Manitoba and Minnesota.

At the same time, the Branchburg-Ramapo 500 kV line was now the remaining link between the Eastern Interconnection and the area ultimately affected by the blackout, and that line disconnected at 4:10:45 along with the underlying 230 and 138 kV ties in New Jersey. This left the northern part of New Jersey connected to New York. Pennsylvania and the remainder of New Jersey remained connected to the Eastern Interconnection.

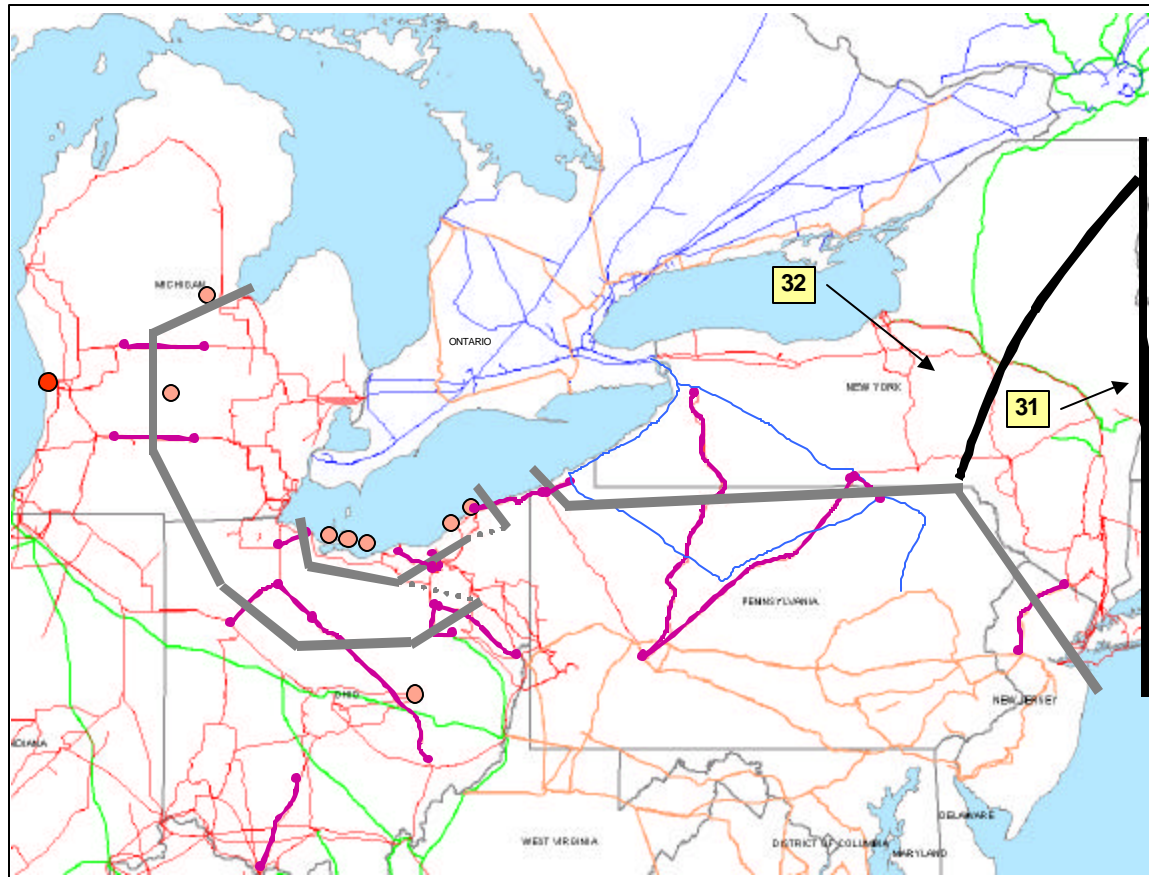
4:10:46 – 4:10:55 PM – New York splits east-to-west. New England (except southwestern Connecticut) and the Maritimes separate from New York and remain intact.

During the next nine seconds, several separations occurred between the areas in the northern section of the Eastern Interconnection.

### 31. 4:10:46– 4:10:55 – New York-New England transmission lines disconnect

The ties between New York and New England disconnected during this period, and most of the New England area became an island with generation and demand balanced close enough that it could remain operational. However, southwestern Connecticut was separated from New England and remained tied to the New York system for about one minute.

### 32. 4:10:48 – New York transmission splits east-west.

The transmission system in New York split along an east-west line, with northern New Jersey and southwestern Connecticut connected to the eastern part of the New York system, and Ontario and eastern Michigan connected to the western part. During the next second, Ontario and New York would separate,

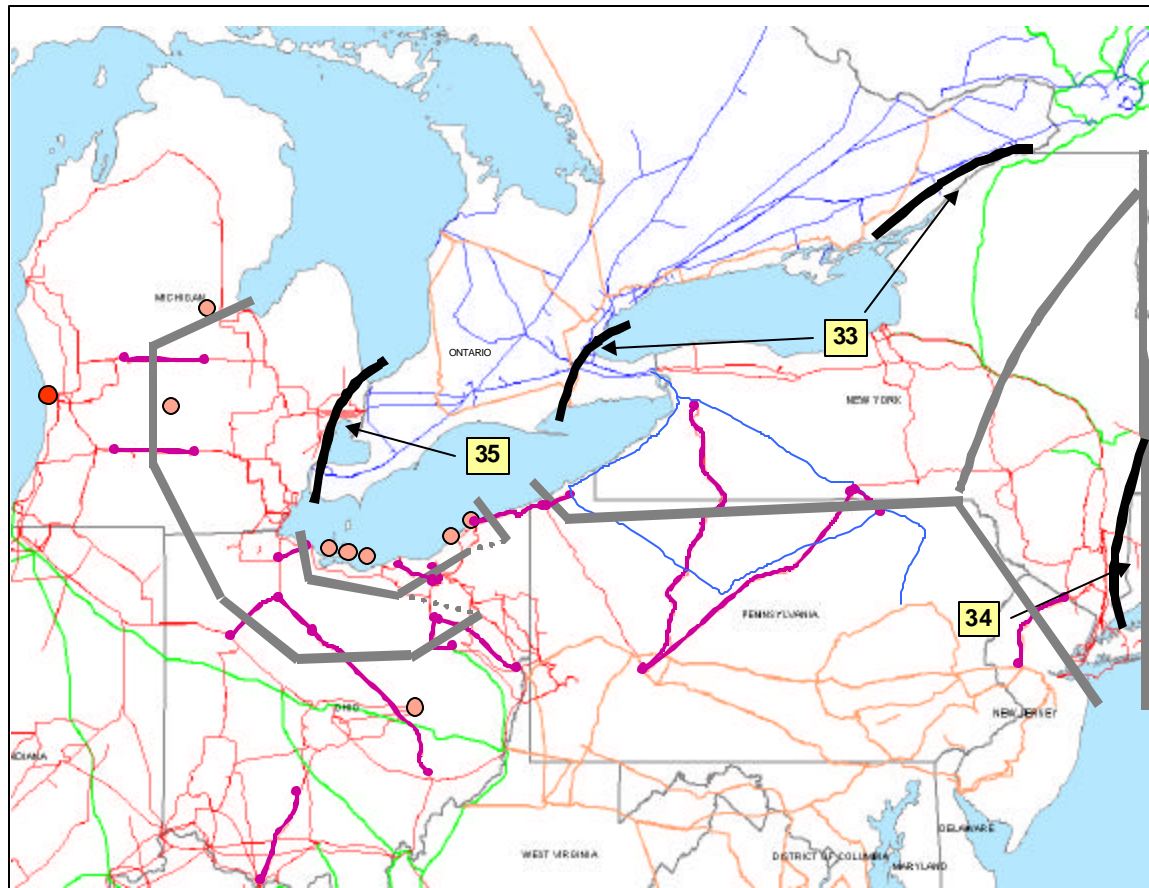
4:10:50 – 4:11:57 PM – Ontario separates from New York west of Niagara Falls and west of St. Lawrence. Southwestern Connecticut separates from New York and blacks out.

33. 4:10:50– The Ontario system just west of Niagara Falls and west of St. Lawrence separates from New York.

34. 4:11:22 – Long Mountain – Plum Tree 345 kV

35. 4:11:57 – Remaining transmission lines between Ontario and eastern Michigan separate

The Ontario-New York separation at 4:10:50 left New York's and Ontario's large hydro and some thermal generators at Niagara and St. Lawrence, as well as the 765 kV and direct current interties with Québec, connected to the New York system, supporting the demand in upstate New York just south of Lake Ontario. Three of the transmission circuits near Niagara automatically reconnected Ontario to New York at 4:10:56. Another 4500 MW of Ontario demand automatically disconnected. At 4:11:10, the Niagara lines disconnected again, and New York and Ontario again separated. Most of Ontario blacked out after this separation, leaving 22,500 MW of demand disconnected out of a total demand of about 24,000 MW. The eastern New York island blacked out with only scattered small pockets of service remaining. The western New York island continued to serve about 50% of the demand in that island.

When Long Mountain-Plum Tree (connected to Pleasant Valley substation in New York) disconnected, it left southwestern Connecticut connected to New York only through the 138 kV cable that crosses Long Island Sound. About 500 MW of southwest Connecticut demand was disconnected by automatic grid operations. Twenty-two seconds later the Long Island Sound cable disconnected, islanding southwest Connecticut and blacking it out.

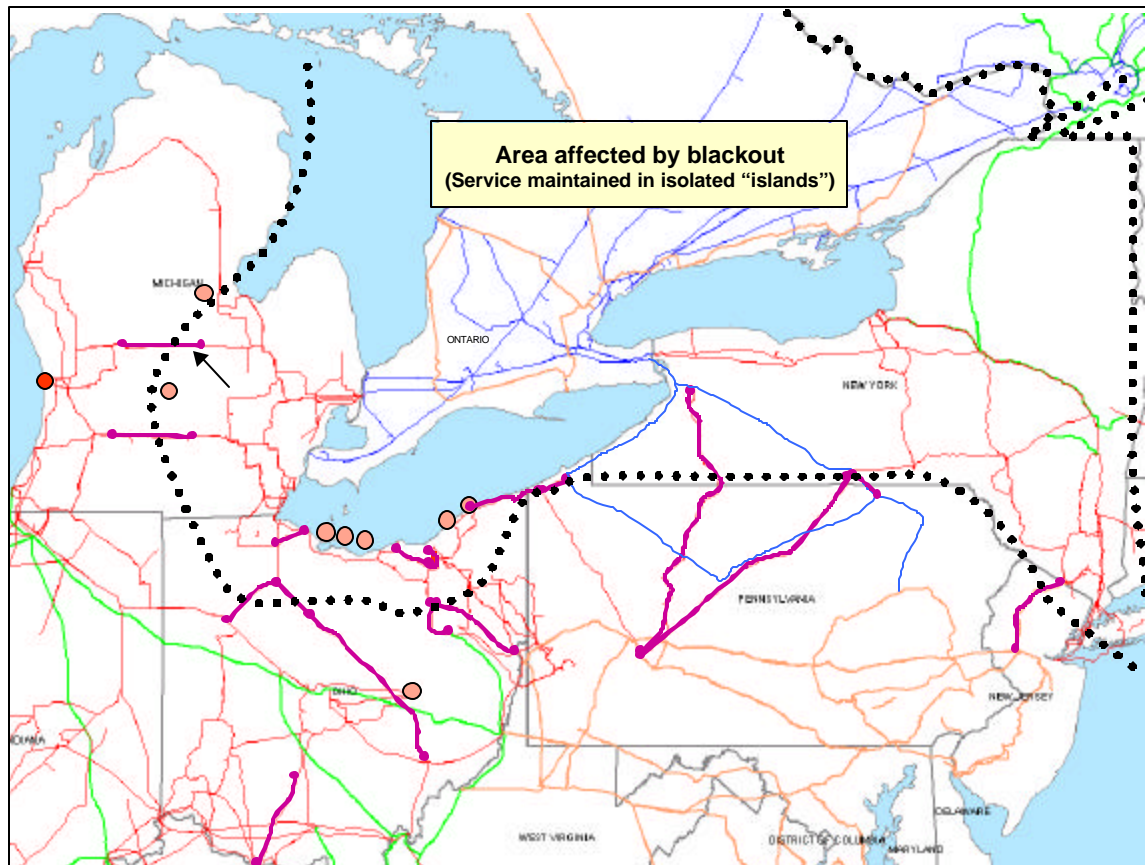
4:13 PM – Cascading sequence essentially complete

The major portion of the northern section of the Eastern Interconnection (the area within the dotted line in the map above) was blacked out.

Some isolated areas of generation and load remained on line for several minutes. Some of those areas in which a close generation-demand balance could be maintained remained operational; other generators ultimately tripped off line and the areas they served were blacked out.

One relatively large island remained in operation serving about 5700 MW of demand, mostly in western New York. This service was maintained by generating stations south of Lake Ontario with Ontario generators at Niagara and St. Lawrence as well as the 765 kV and DC interties with Québec. This island formed the basis for restoration in both New York and Ontario.
